MISCELLANEOUS PAPER SL-82-1

DURABILITY OF REINFORCED CONCRETE BEAMS EXPOSED TO MARINE ENVIRONMENT

Structures Laboratory

April 1982
Final Report

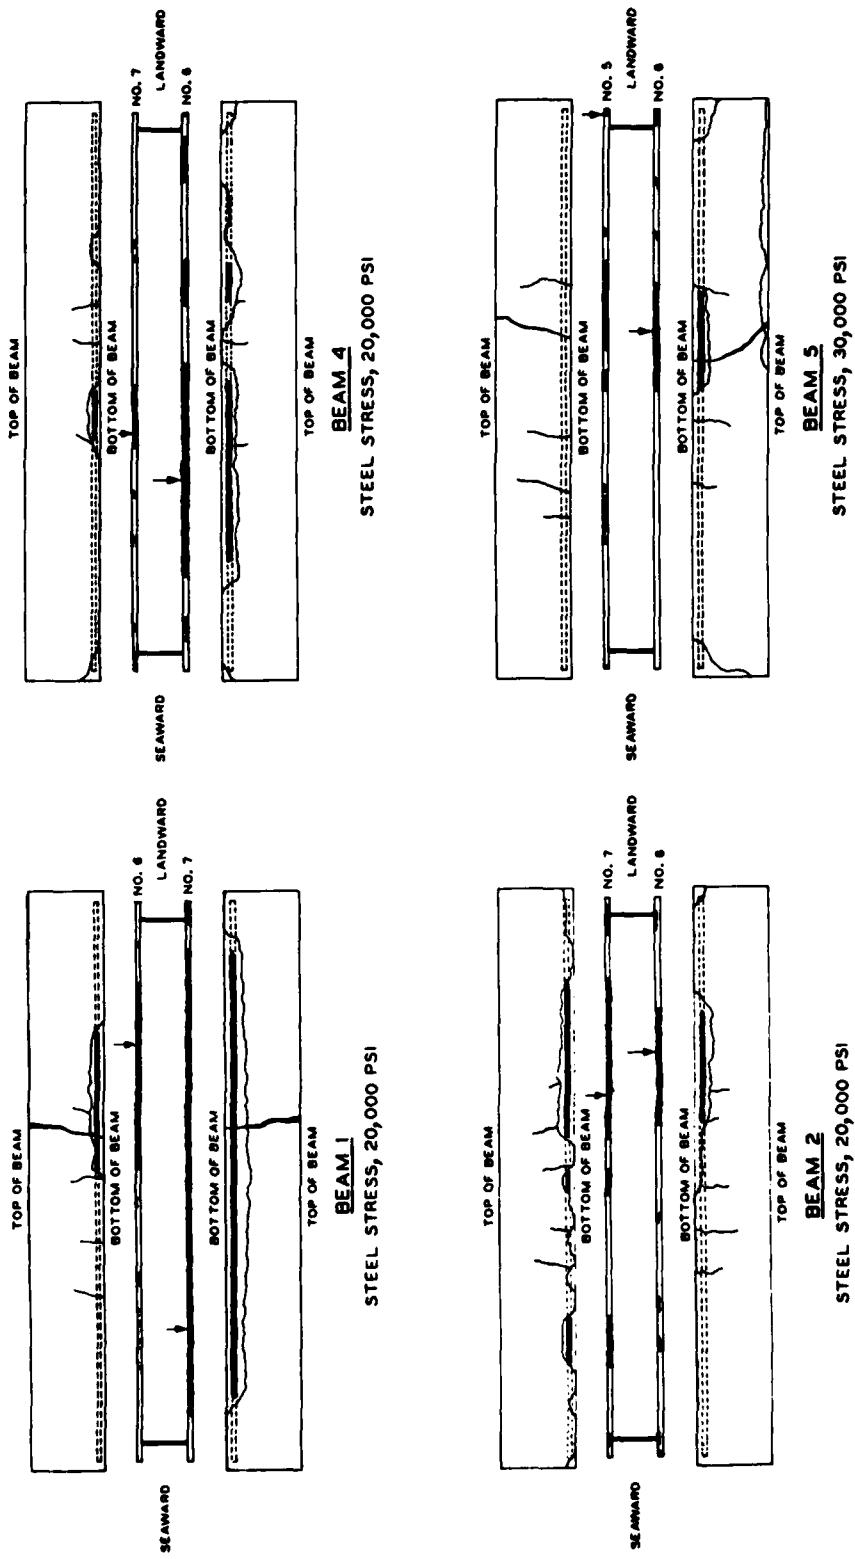
As a general remark, the steel beneath the 19-mm cover was not heavily rusted. There were areas that did receive corrosion where the concrete cover was still intact, such as the tips of the reinforcing bars, but on the whole, areas where the bars were not directly exposed to oxygen and seawater remained only lightly rusted. Where the concrete cover had spalled, the steel was heavily rusted from direct exposure to the harsh environment.

Figures 3 through 8 are graphic representations of the beams in the "as received" condition. Each figure shows both faces of the beam and all areas of the reinforcement that were exposed. They also show the longitudinal and flexural cracks, spalled areas, and corrosion to the reinforcement. The sketch between the faces of the beams shows the condition of the reinforcement after it was removed from the concrete. The darkened areas on the bars represent the corroded areas. The figures show that the number and depth of flexural cracks increased with the increase in steel stress. They also show that the corrosion on the bars does not align with the flexural cracks in the concrete at lower steel stress levels. The corrosion on the bars that were stressed in the 138-MPa stress range was, in general, at different locations than the flexural cracks. The corrosion at spalled areas was confined to the area of the steel directly exposed to water and oxygen; however, where there were flexural cracks and the concrete was not spalled, the bars beneath remained free from corrosion. In the higher stress ranges, 207 and 276 MPa, the corroded areas of the steel more generally matched the location of the flexural cracks (Figures 6 and 7).

Figure 3. Graphic representation of cracking and corrosion, beams 1 and 2

Figure 4. Graphic representation of cracking and corrosion, beams 4 and 5

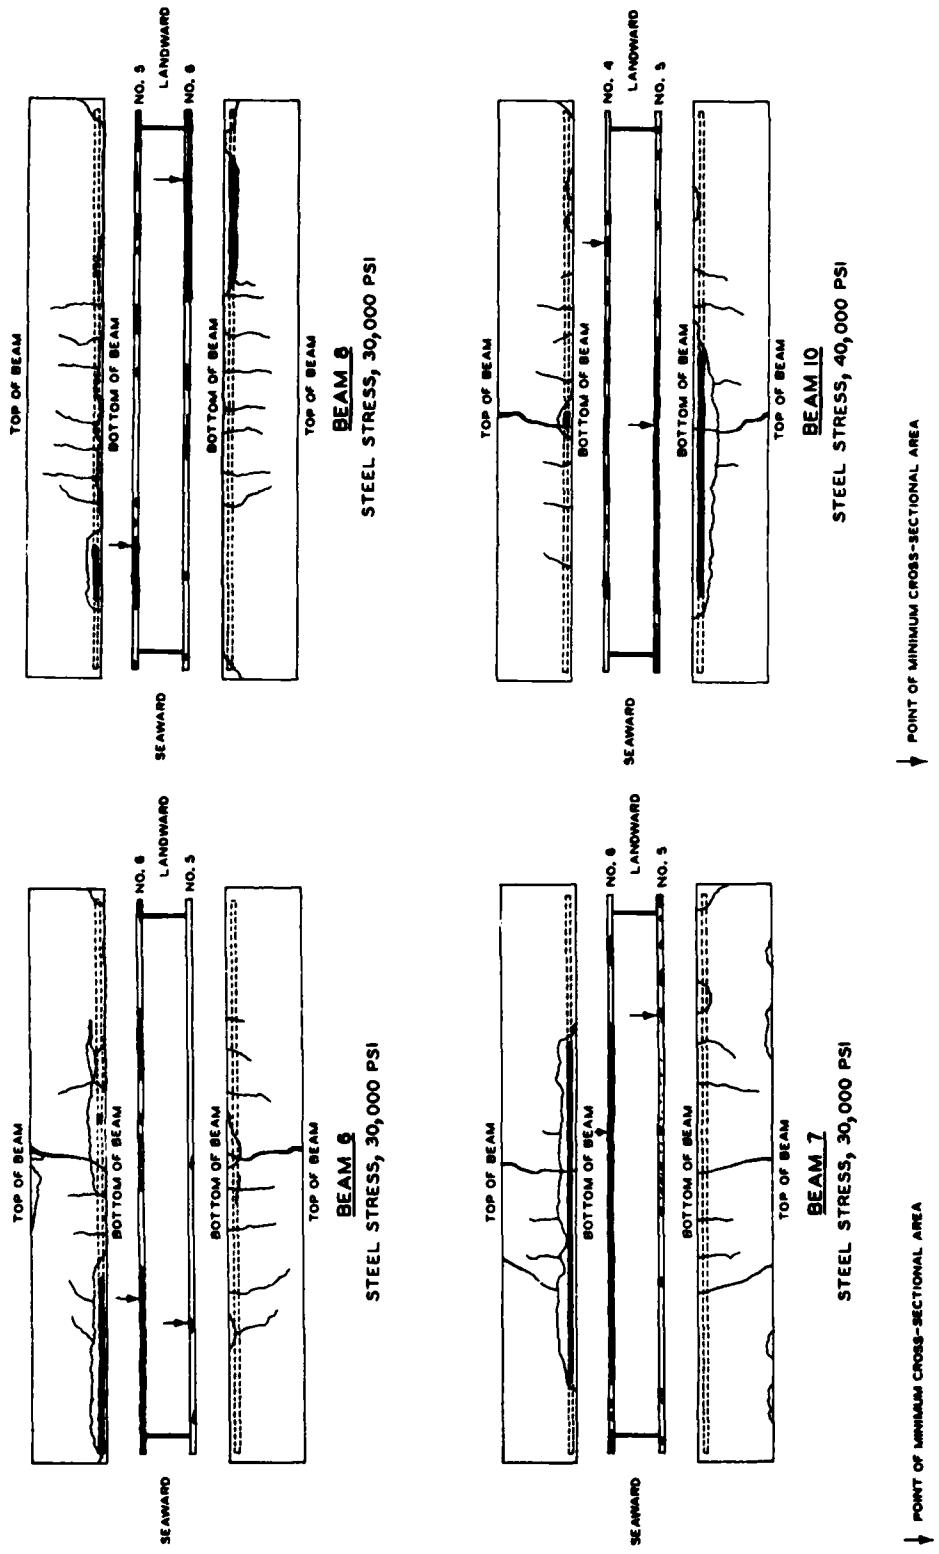
Figure 5. Graphic representation of cracking and corrosion, beams 6 and 7

Figure 6. Graphic representation of cracking and corrosion, beams 8 and 10

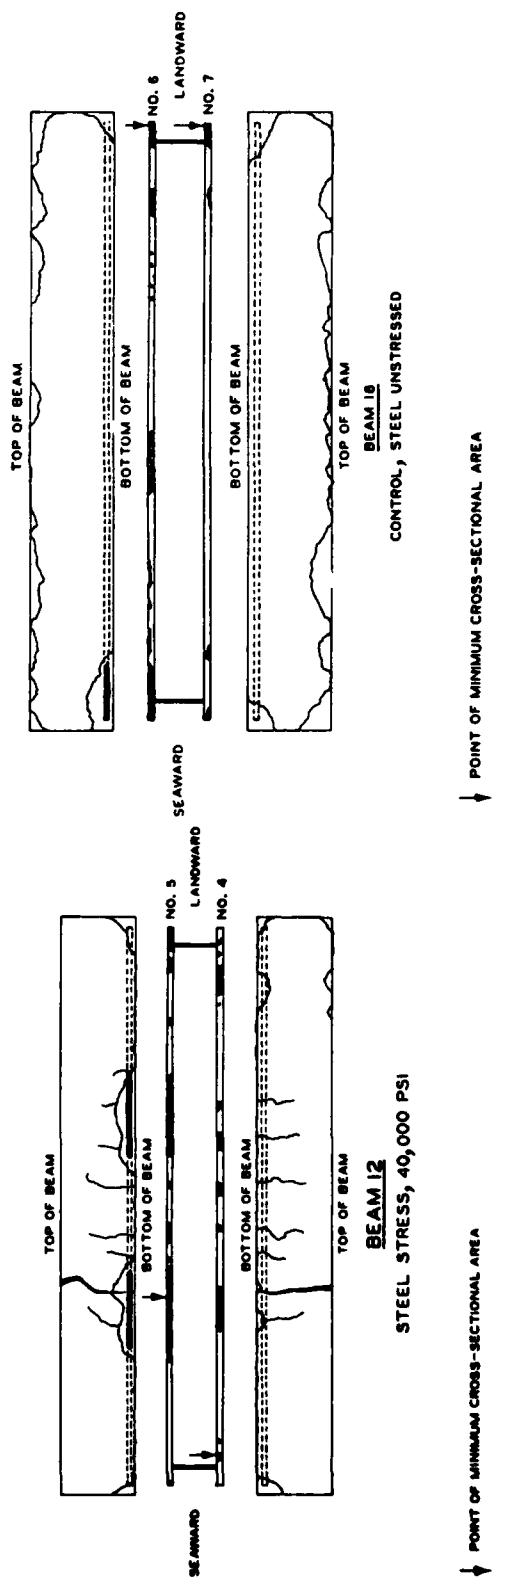
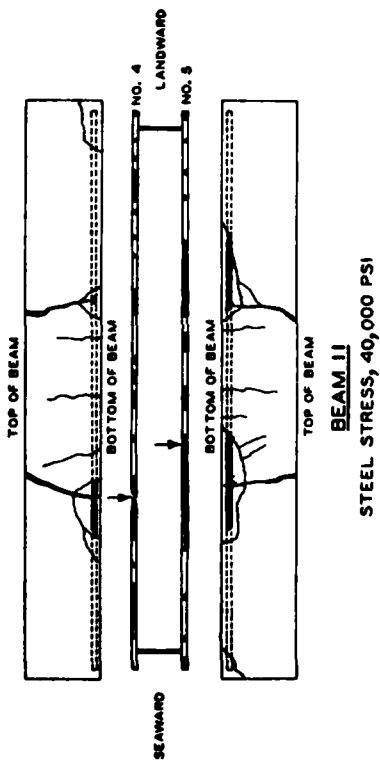
Figure 7. Graphic representation of cracking and corrosion, beams 11 and 12

Figure 8. Graphic representation of cracking and corrosion, beam 18
